TAUNTON RIVER BASIN
BROCKTON, MASSACHUSETTS

LOWER PORTER POND DAM
MA 00424

PHASE I INSPECTION REPORT
NATIONAL DAM INSPECTION PROGRAM

JANUARY 1980

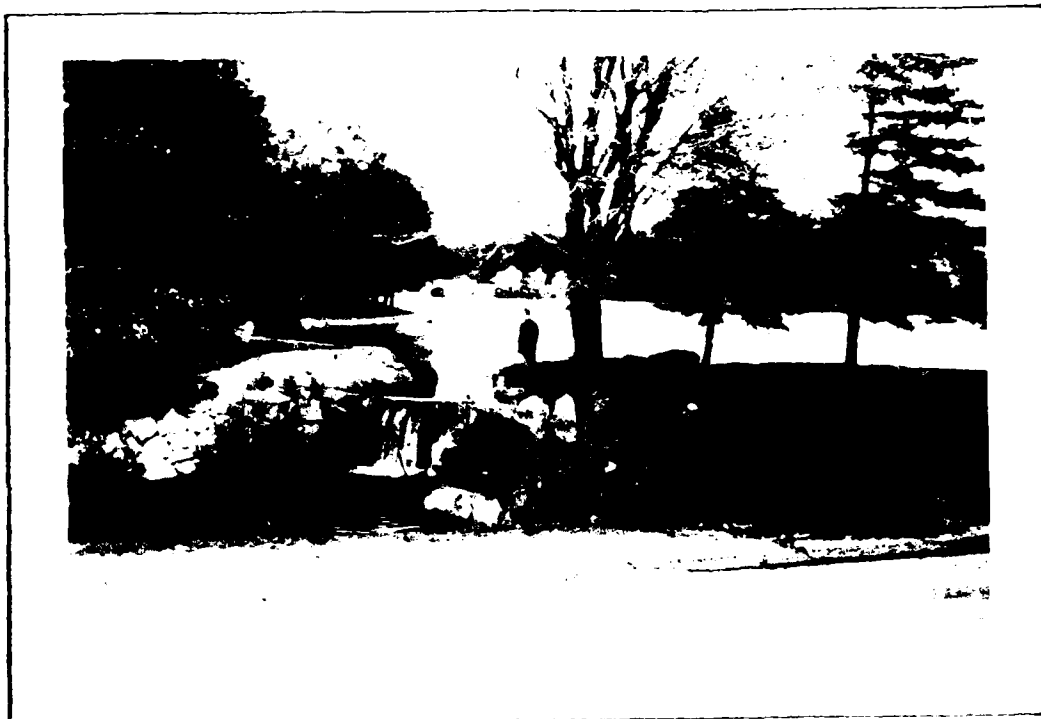
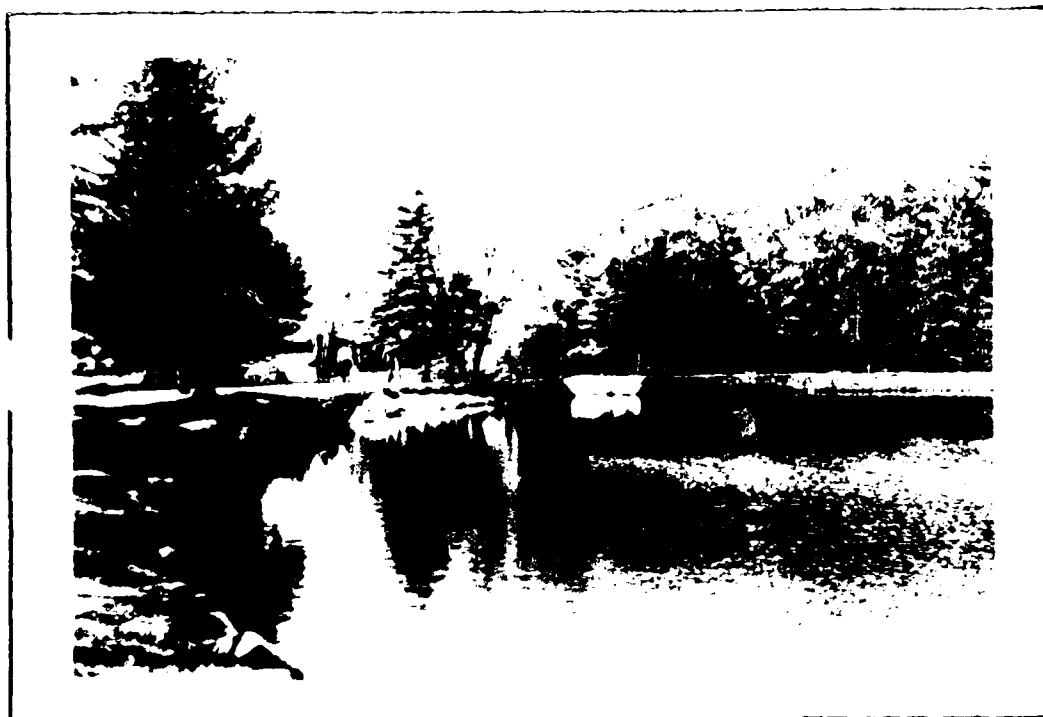
AN OVERVIEW OF THE LOWER PORTER POND DAM. (10/17/79)

a. Condition. The visual observations and review of the available information indicate that Lower Porter Pond Dam is in fair condition. The roots of trees growing on the dam crest may increase the seepage potential and high winds may dislodge the trees removing significant portions of embankment material. The absence of grass cover on a portion of the dam crest exposes the embankment to undesirable surface erosion.

3) The trees and their root systems should be removed from the embankment to the extent possible and the voids in the embankment replaced with appropriate compacted embankment materials.

- 1) The bare spots on the embankment crest should be covered with suitable vegetation and protected from pedestrian traffic.
- 2) Erosion protection should be provided for the upstream slope of the embankment.
- 3) The operating condition of the pond drain sluice gate should be determined and the gate should be repaired, if necessary. The gate operator should be stored in a convenient location for emergency use.
- 4) A program of annual periodic technical inspection should be instituted.
- 5) A formal surveillance and flood warning plan, including round-the-clock monitoring during heavy precipitation, should be developed.

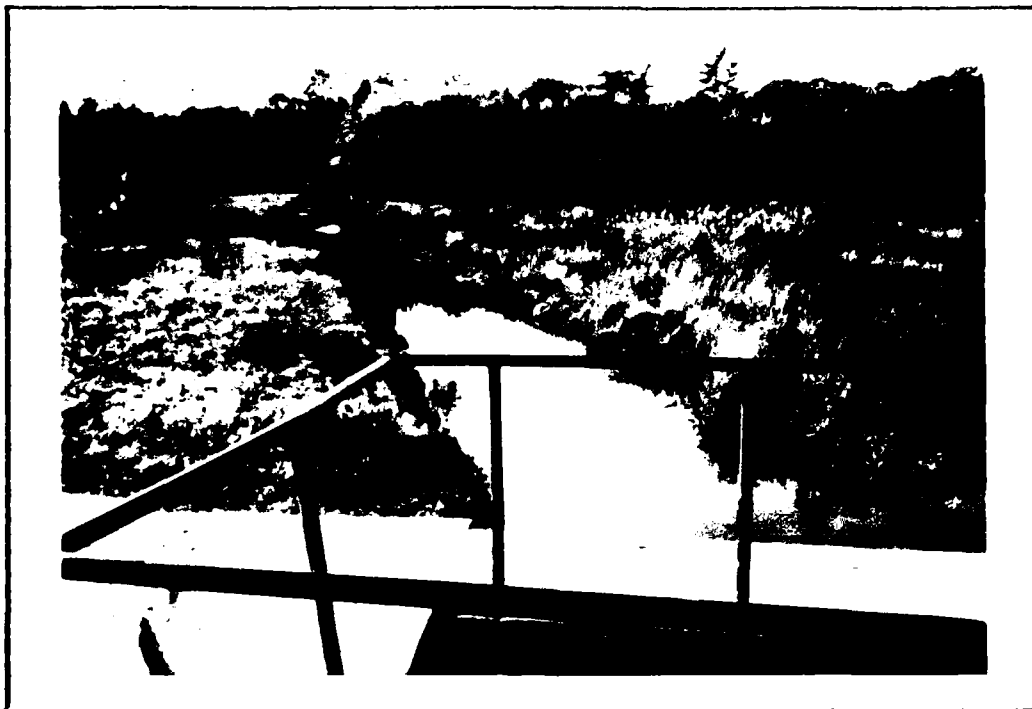
9. E. BRETT POND (DRAINED) INLET STRUCTURE ABOUT 1150 YARDS DOWN-
STREAM OF LOWER PORTER POND DAM. (10/17/79)

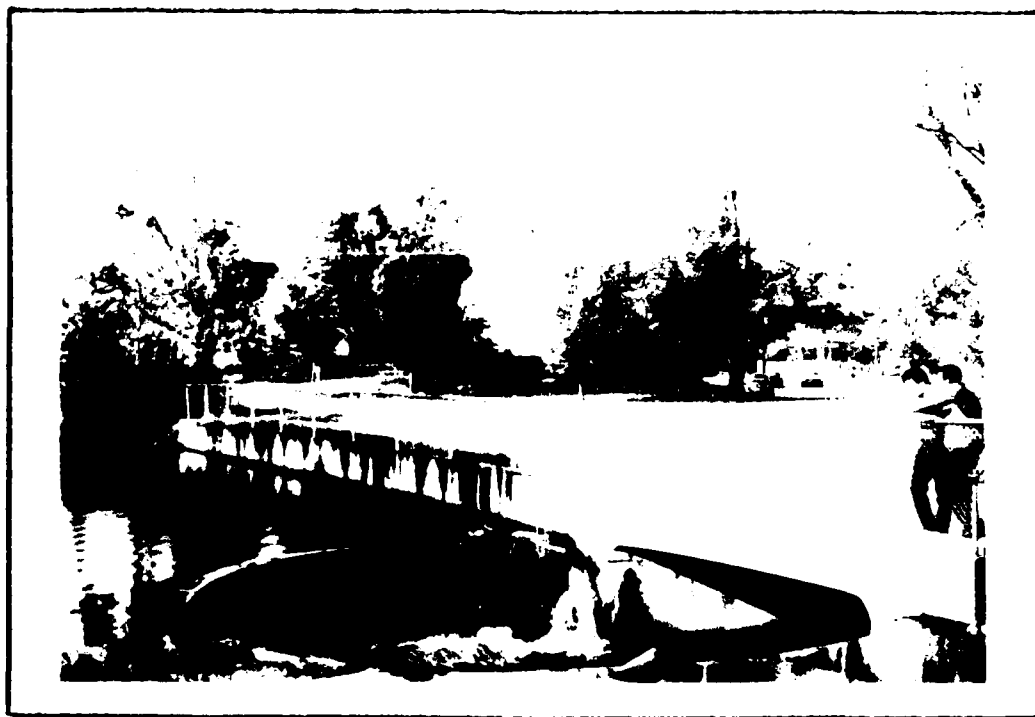
10. CROSS POND SPILLWAY APPROXIMATELY 1450 YARDS DOWNSTREAM OF LOWER
PORTER POND DAM. (10/17/79)

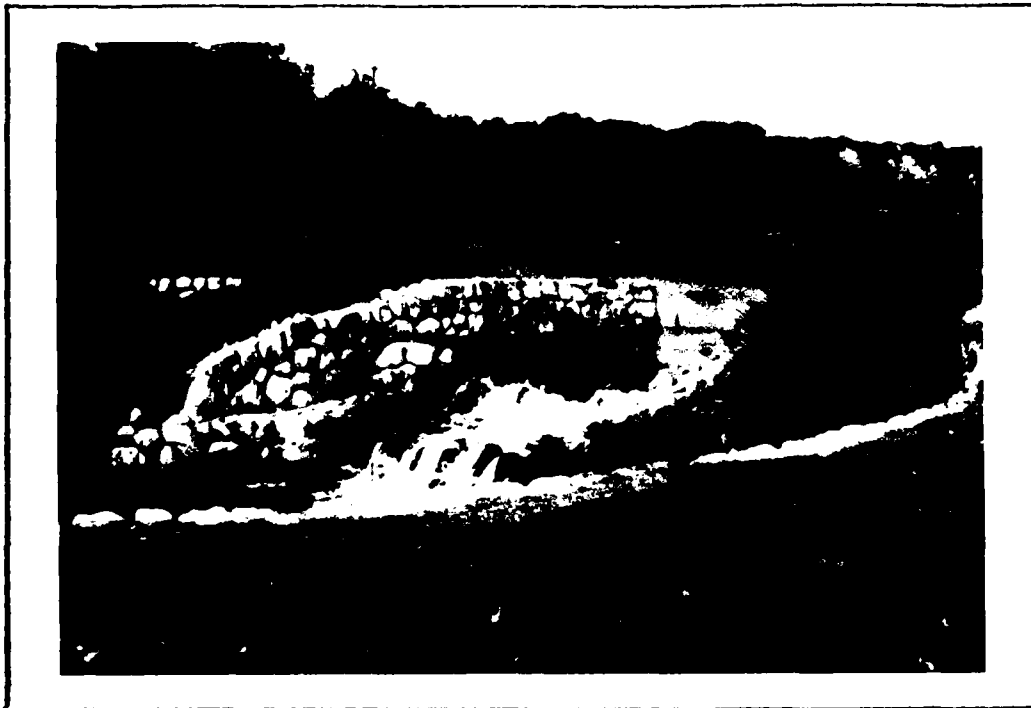
7. UPPER PORTER POND DAM SPILLWAY APPROXIMATELY 350 YARDS UPSTREAM OF LOWER PORTER POND DAM. (10/17/79)

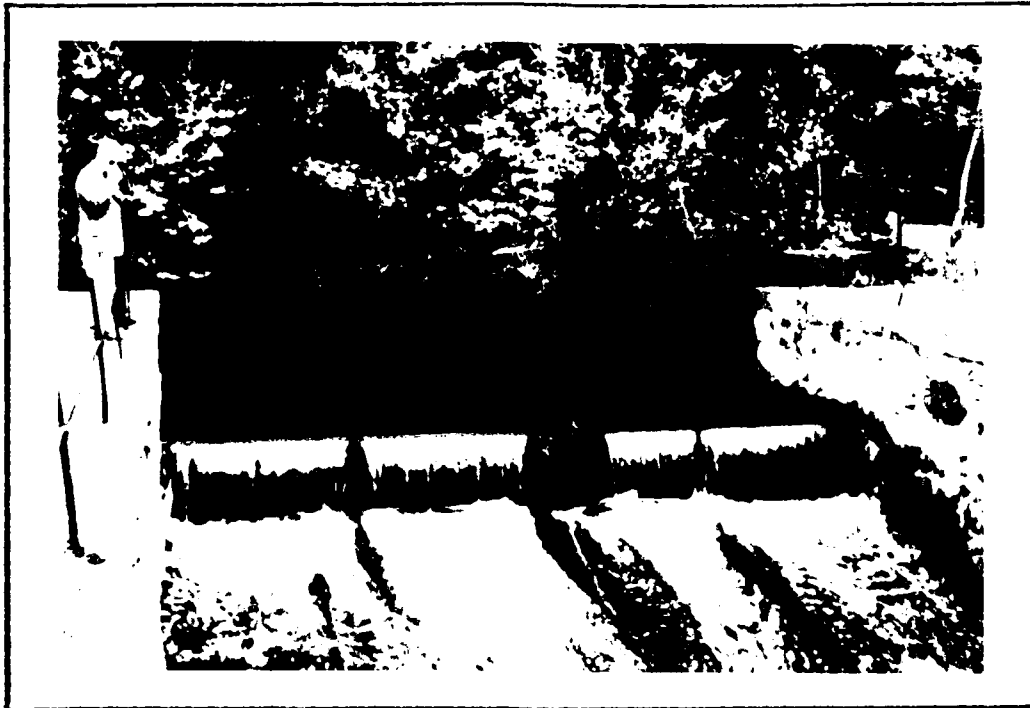
5. BROCKTON RESERVOIR DAM SPILLWAY APPROXIMATELY 2100 YARDS UP-
STREAM OF LOWER PORTER POND DAM. (10/17/79)
